RUBBER CONTACT

Article written by Stacy Ledou
West County Transportation Agency

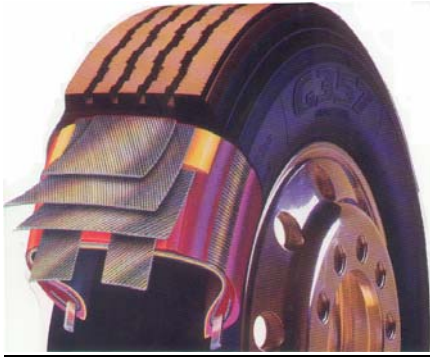
Fig. A

You saw a cutaway of a tire case. You can see the steel wire in the case it goes from side to side. This makes up the sidewall strength, which makes the tire case round. The other metal bands you see are the metal ply's that give the tire its load rating.

These strands are intertwined with the metal belts that you see layered. Ok you can look again. This makes up a steel hoop that will be put into a mold, which will have a special rubber compound poured in and then it is cured.

**If you look at (fig A)
Go ahead do it now.**

Under the sidewall rubber the metal strands will break because of the sudden flexing that it was not intended to do. When this happens the metal strands in the sidewall can become frayed or snap, this can allow air to get between the sidewall and the metal strand this is known as blister. A common

phrase you may have heard is separation - this is when the section of metal strands or a metal belt will break which will cause a lump in the tire case sidewall.

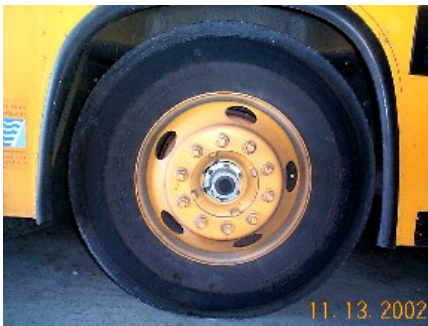
You can do serious damage to the tire case and all steering components when you come in contact with a fixed object.

Remember that you cannot see the damage just the scuff mark (*your signature*) on the sidewall. You may not know this but the tire on your bus costs the agency \$280.00 to \$325.00.
